**THE  
ONTARIO WATER RESOURCES  
COMMISSION**

**WATER POLLUTION SURVEY  
OF  
COBOURG BROOK  
WITH PERTINENT  
MUNICIPAL SANITARY SURVEY REPORTS  
ON  
TOWN OF COBOURG  
TOWNSHIP OF HAMILTON**

**JUNE 14th, 15th, 16th, and 27th,**

REPORT ON  
WATER POLLUTION SURVEY  
OF  
COBOURG BROOK  
WITH PERTINENT  
MUNICIPAL SANITARY SURVEY REPORTS  
ON  
TOWN OF COBOURG  
TOWNSHIP OF HAMILTON

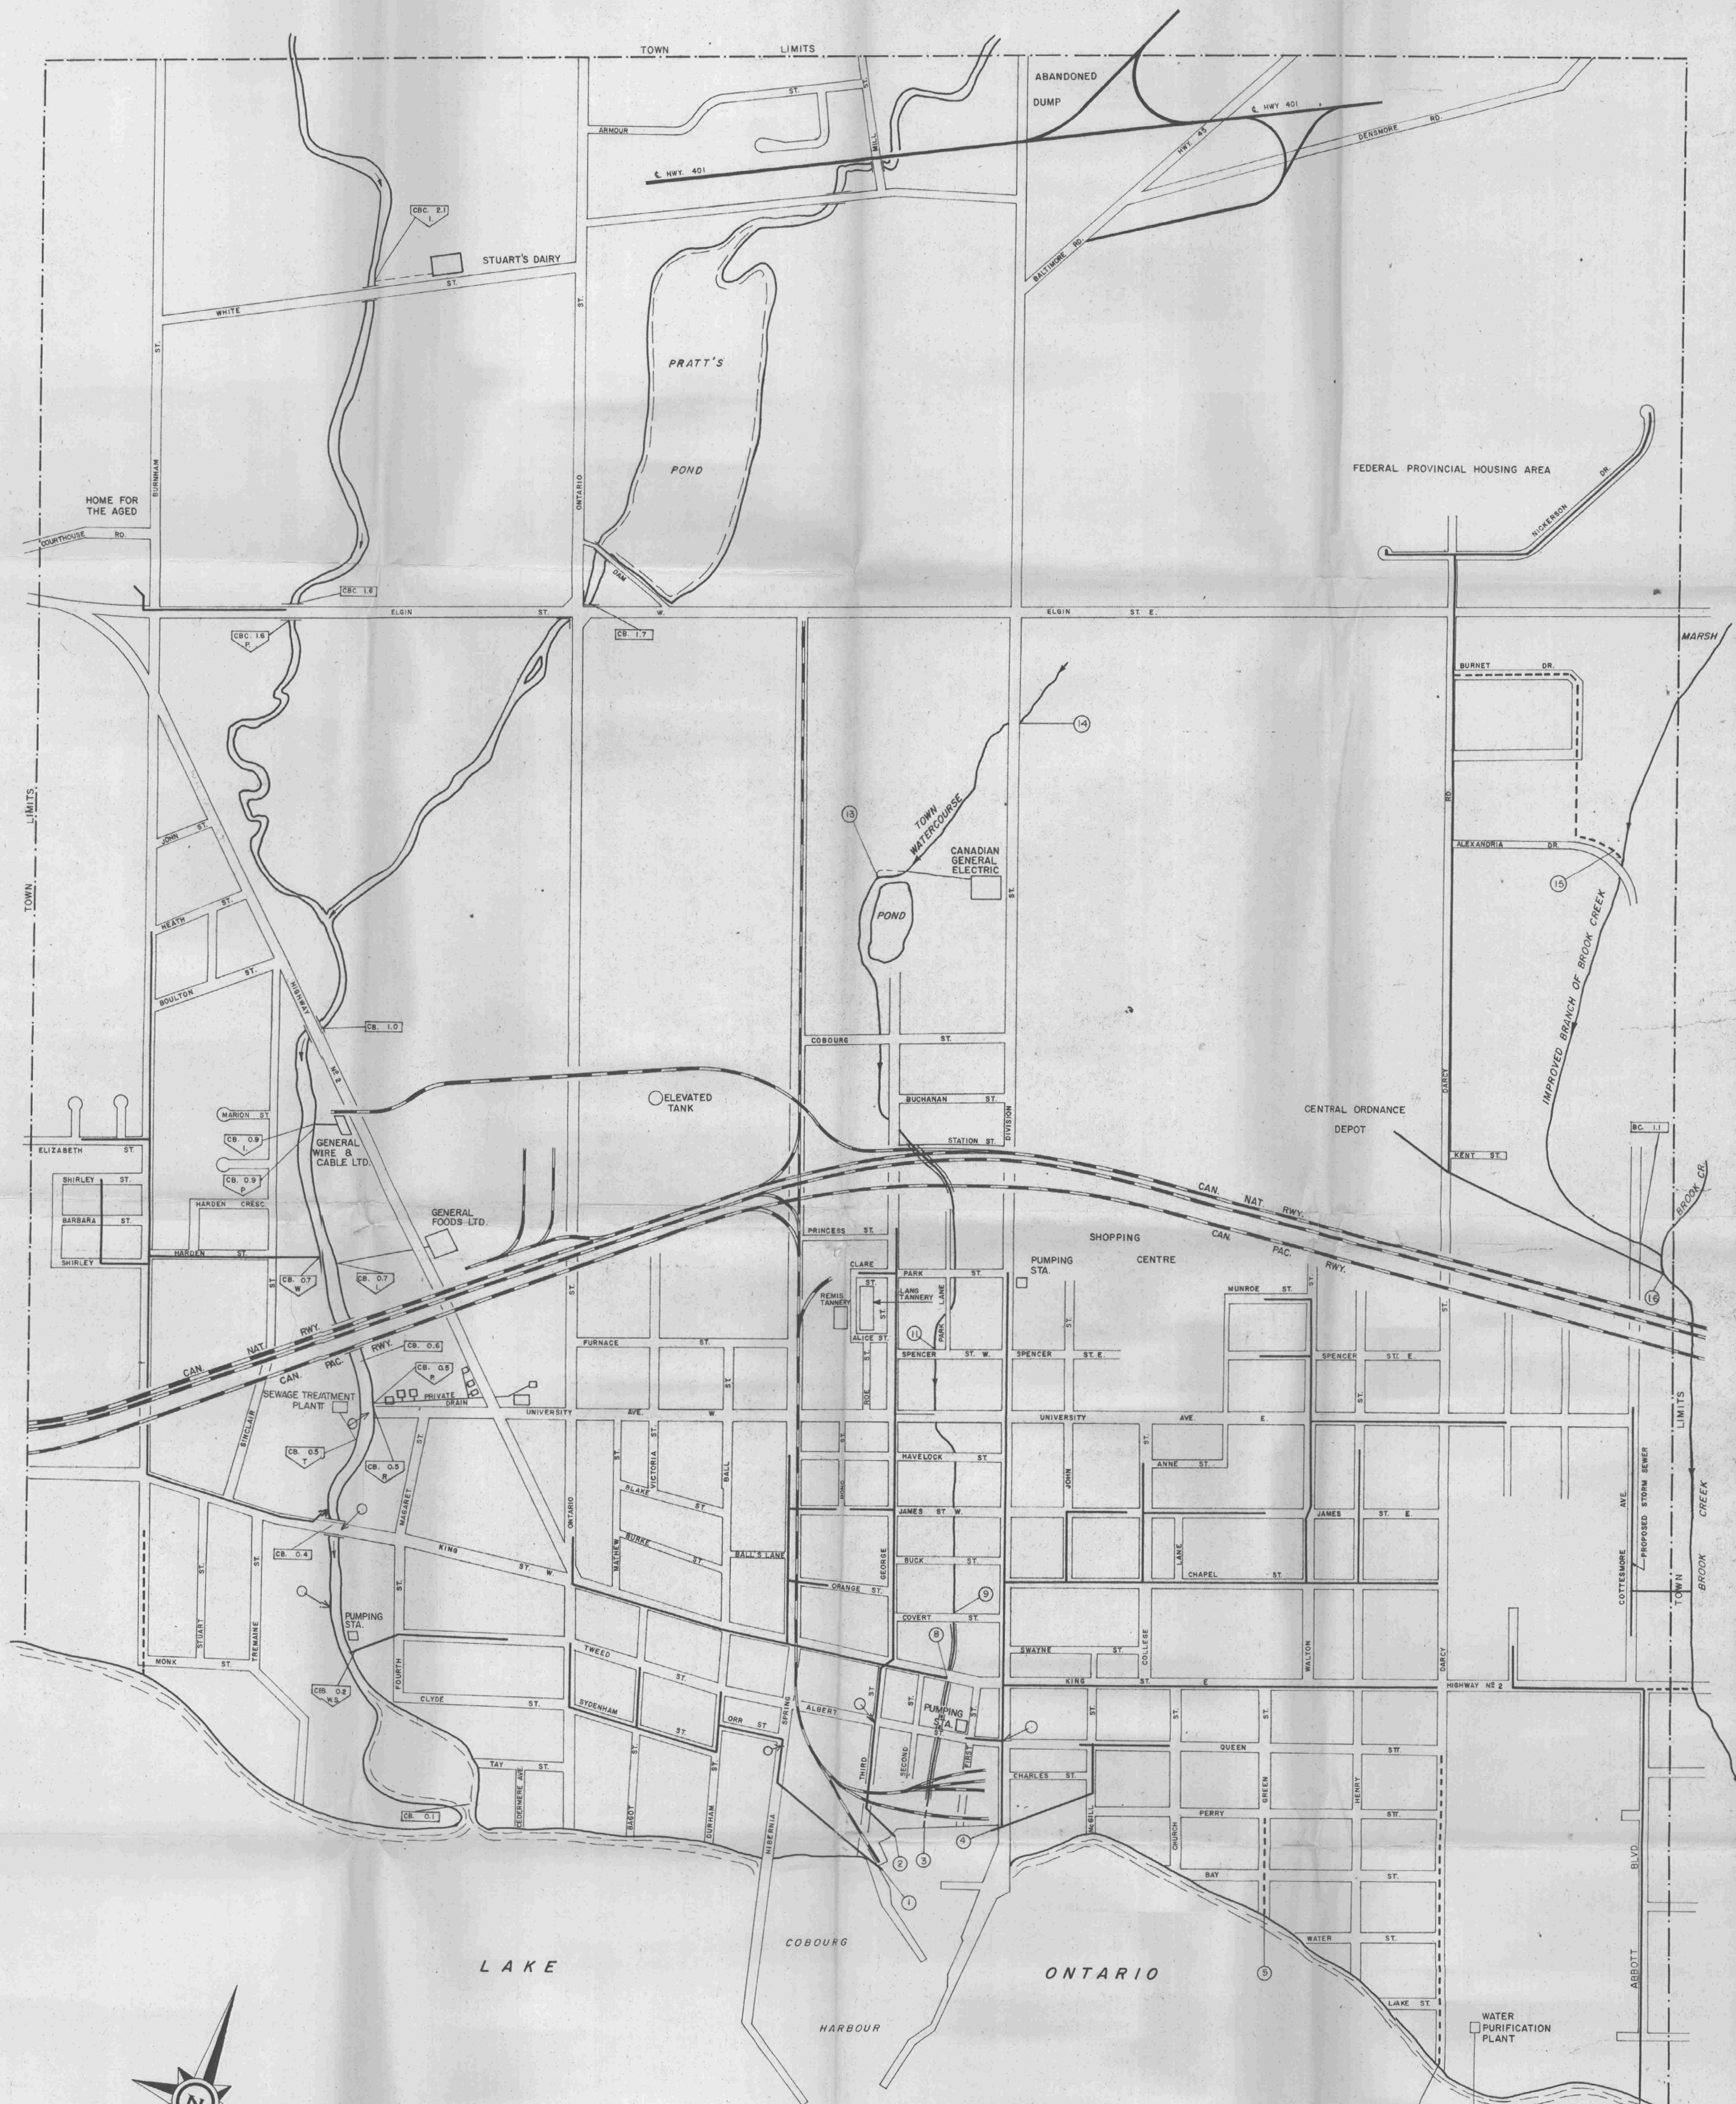
# TOWN OF COBOURG

Appended is a map of Cobourg showing the sampling points within this municipality. Tables #2,3, and 4 show the results of outfall samples collected at Cobourg.
